NRL/FR/6180--97-9861

Virtual Environment Firefighting/Ship Familiarization Feasibility Tests

VIRTUAL ENVIRONMENT FIREFIGHTING/SHIP FAMILIARIZATION FEASIBILITY TESTS

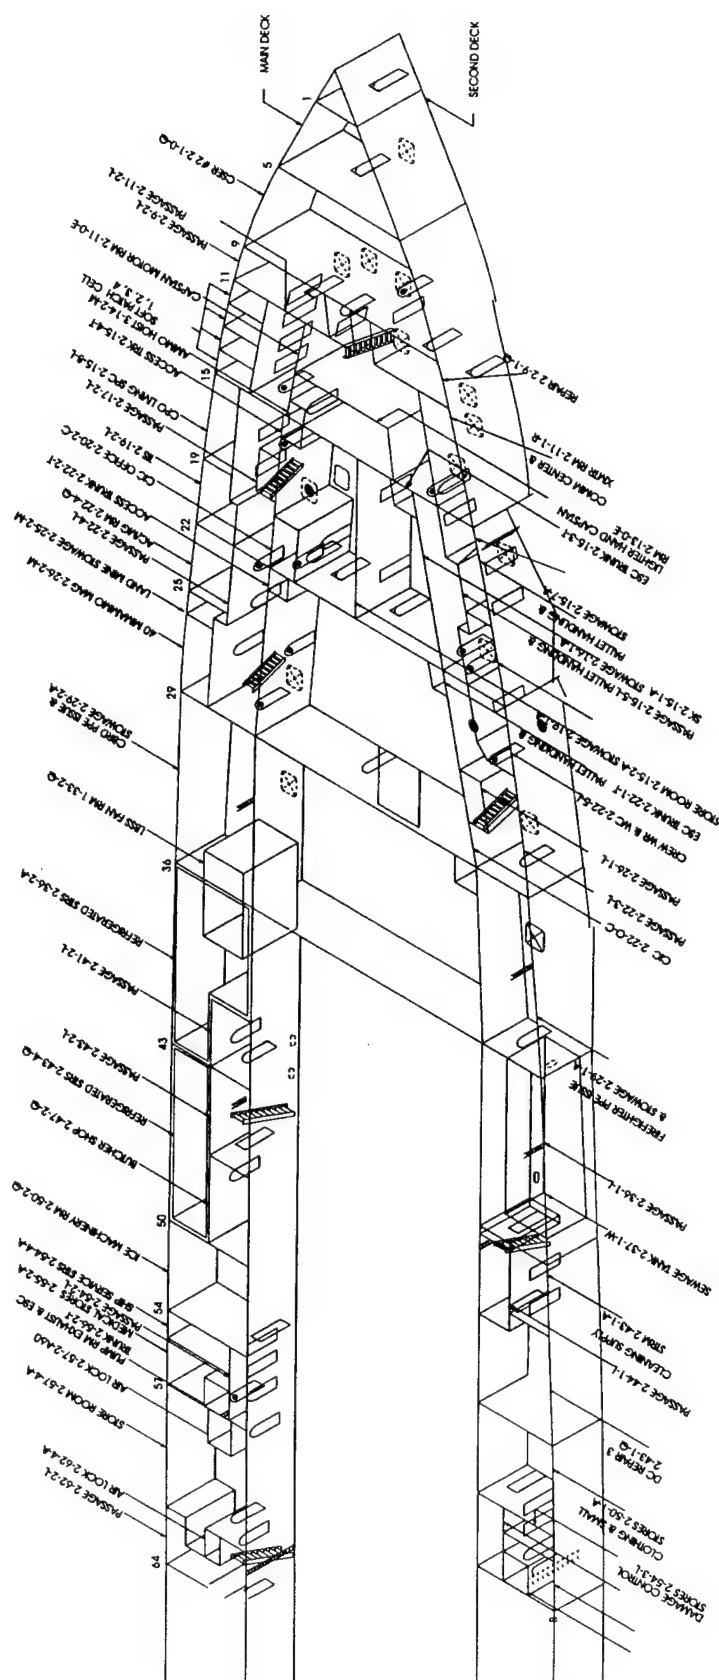
Fig. 6 --- Portion of DC plates showing Second Deck

The fire tests were conducted in the forward area of the ex-USS *Shadwell*, on the First (Main) and Second Decks between FR 9 and FR 22 (Figs. 5 and 6). The actual test area was on the Second Deck between FR 15 and FR 22 (Fig. 6). This area had been modified from its original configuration for the 1994 Attack Team Workshop [5] by the addition of the fore-to-aft centerline bulkhead. The compartment to port of the centerline bulkhead is designated as the Storage Area (2-15-2-A), and the compartment to starboard is designated as the General Store Keeping (GSK) Office (2-15-1-Q). The centerline bulkhead has two joiner doors, one forward at FR 16 and another aft at FR 20, to provide access between these two compartments.

The fire area was in the aft portion of the storage area compartment (Fig. 6). Access to the fire area was via the starboard passageway through water-tight door QAWTD 2-17-1 into GSK, and then through the forward joiner door into the fire space. Repair 2 (2-9-1-Q) was used as the staging area for the attack team. The fo'c'sle area forward of the Ship Fitter's Shop (1-15-0-E) on the Main Deck, and Combat Information Center (CIC) aft (2-22-0-C) on the Second Deck served as emergency escape and muster areas.

The layouts of the First (Main) and Second Deck test areas are shown in Figs. 5 and 6. Dimensional details of these areas are presented in Appendix A of Ref. 5. The staging area for the attack team was in the athwartship passageway adjacent to Repair 2 (2-9-1-Q). The team leader dressed out on the fo'c'sle prior to joining the rest of the attack team at Repair 2. Accesses used by the attack team to reach the fire compartment included QAWTD 2-15-1, QAWTD 2-17-1, and JD 2-17-0. The dimensions of the quick-acting watertight doors were 170 × 66 cm (66 × 26 in.), and the joiner doors in the centerline bulkhead were 210 × 61 cm (84 × 24 in). Emergency exit routes available to the attack team were FD 2-22-1 to the CIC aft safety area or QAWTD 2-17-1 and QAWTD 2-15-1 back to Repair 2 and then up to the fo'c'sle via the booby hatch at FR 11.

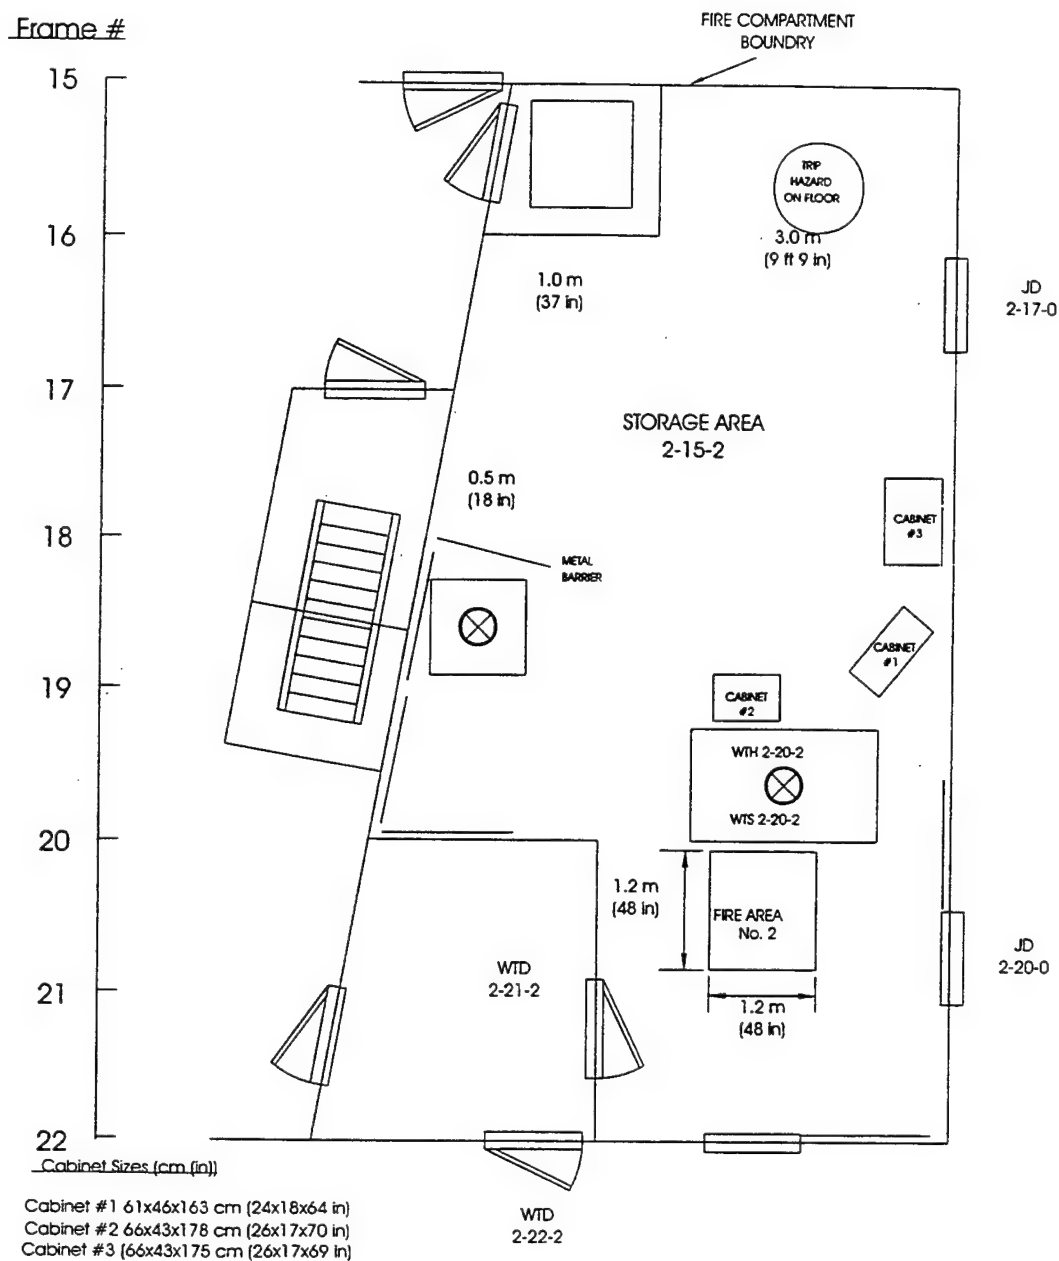
Fig. 8 — Second deck fire source and obstruction layout plan view, FR 15-22

Simulation of a typical storage area fire having a single fire source was provided by burning a wood crib. To further simulate a storage area fire and to make the attack more challenging, metal panels and lockers were located around the compartment such that they obstructed direct access to the fire source. The exact locations of the fire source and obstructions are shown in Fig. 8. The wood crib was made from red oak sticks cut to a nominal size of 5 × 5 × 120 cm (2 × 2 × 48 in.) and was assembled in place on a metal grate support stand that was 58-cm (23-in.) high (Fig. 9). The square wood crib had a total of 10 layers of sticks. Each layer had 10 sticks, with successive layers being placed perpendicular to each other. A 91-cm (36-in.) square metal pan located under the support stand was used to hold the initiating fuel. The initiating fuel was 19 L (5 gal) of commercial grade n-heptane. The metal panels used as obstructions were all 1.2-m (4-ft) high (Fig. 10).

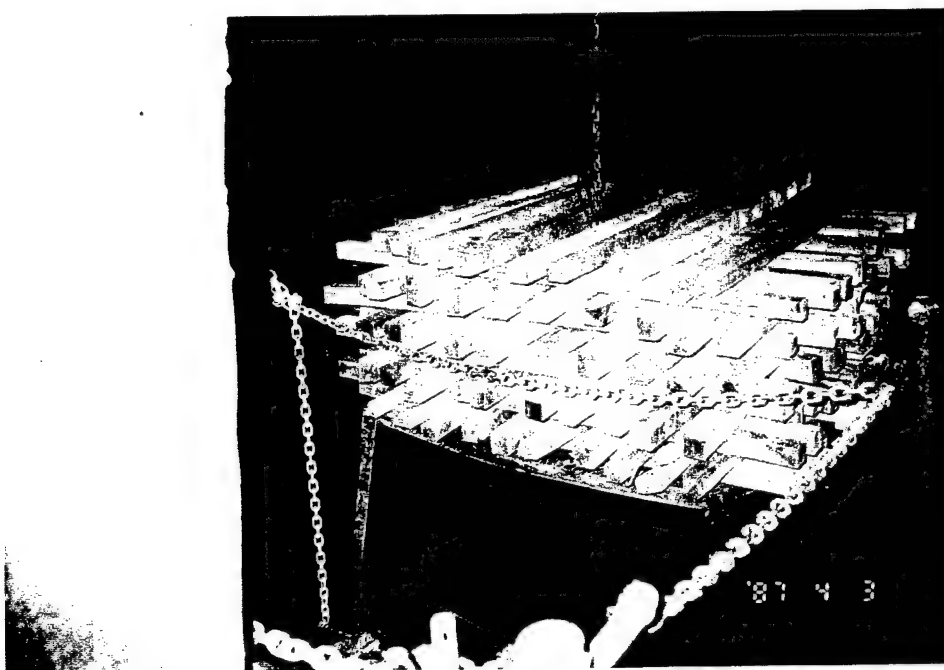
Fig. 9 — Wood crib assembled on support stand with initiating fuel plan below (shown without obstructions)

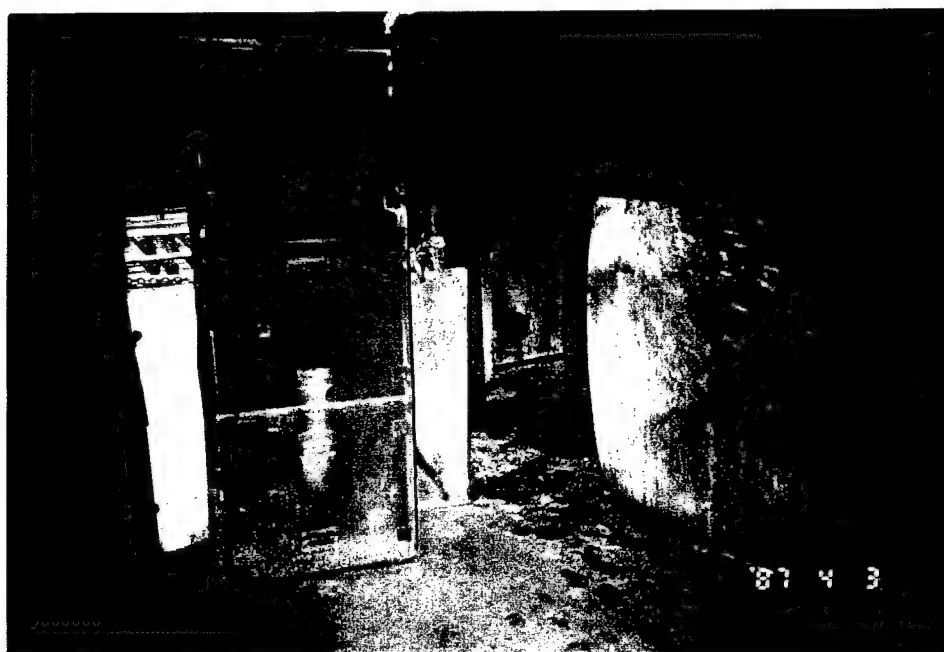
Fig. 10 — Obstructions located in front of and adjacent to fire source

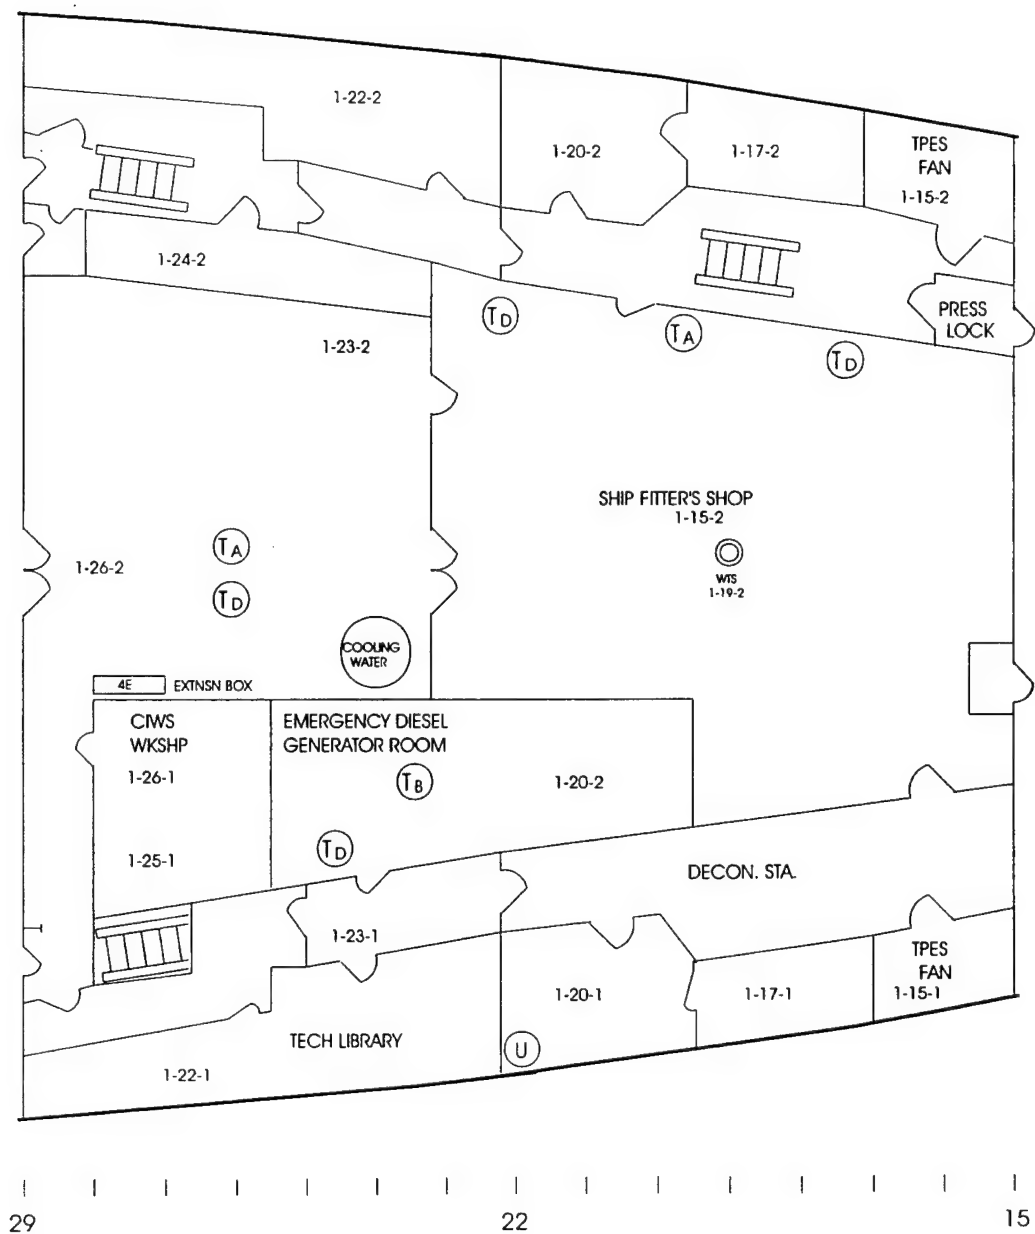
Fig. 11 — First (Main) Deck instrumentation layout plan view, FR 15-29

The locations of all instrumentation installed for these tests are shown in Figs. 11 and 12. The symbol legend for the instruments shown in these figures is provided in Table 1 along with notes on instrumentation that was out of service for specific tests. Key instruments located in the Second Deck test area are shown on Fig. 12 and are described below.

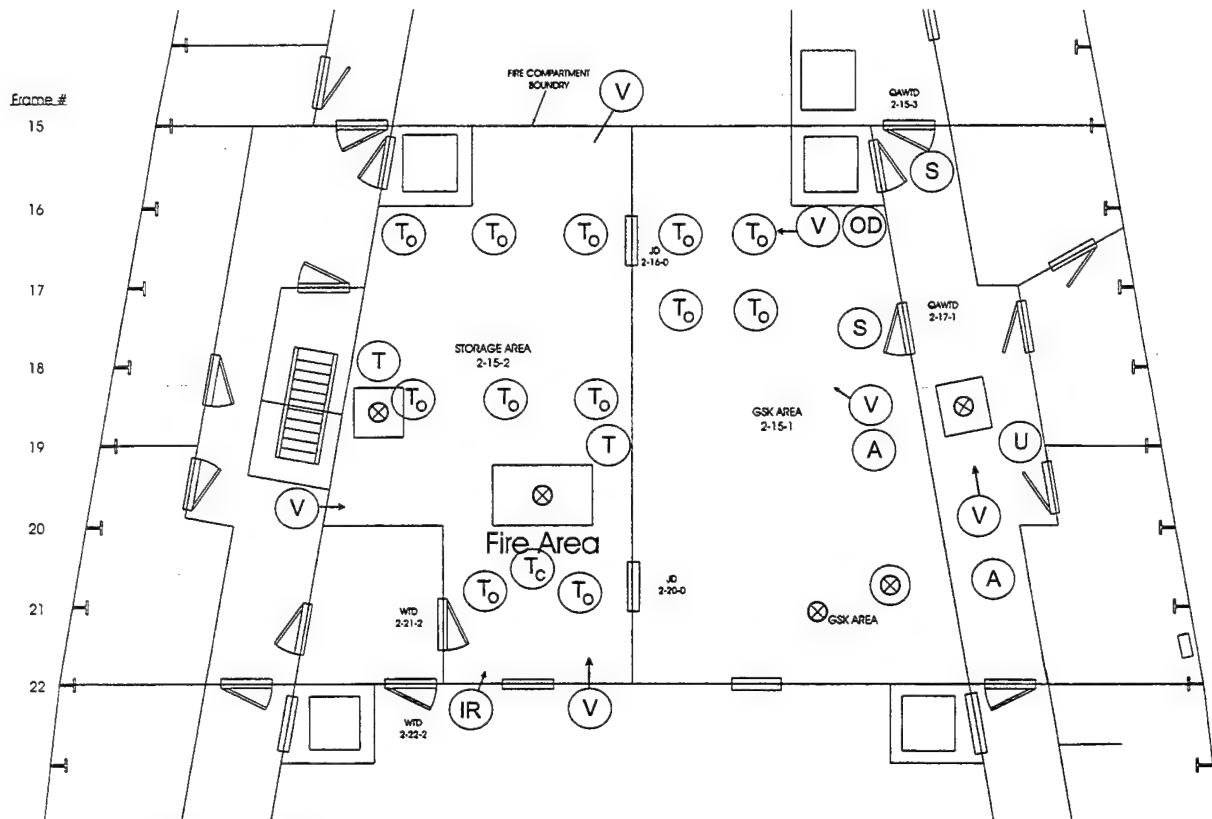
Note: See Table 1 for Symbol Legend.

Fig. 12 — Second Deck test area instrumentation layout plan view, FR 15-23

Type K inconel-sheathed thermocouples, 3.2-mm (0.13-in.) outside diameter and 1.6-mm (0.06-in.) outside diameter were used to measure air, overhead, and crib flame temperatures. Two vertical thermocouple strings mounted on stands located at FR 18 on the port side of the fire compartment (2-15-2) and at FR 19 on the starboard side of the fire compartment (2-15-2) measured air temperatures. The thermocouples were mounted on the stands at 46 cm, 91 cm, 140 cm, 180 cm, 230 cm, and 274 cm (18 in., 36 in., 54 in., 72 in., 90 in., and 108 in.) above the deck. Overhead thermocouples mounted 15 cm (6 in.) below the overhead were located in the bays formed by the overhead structural framing immediately aft of FR 16, FR 18, and FR 20 in the storage area.

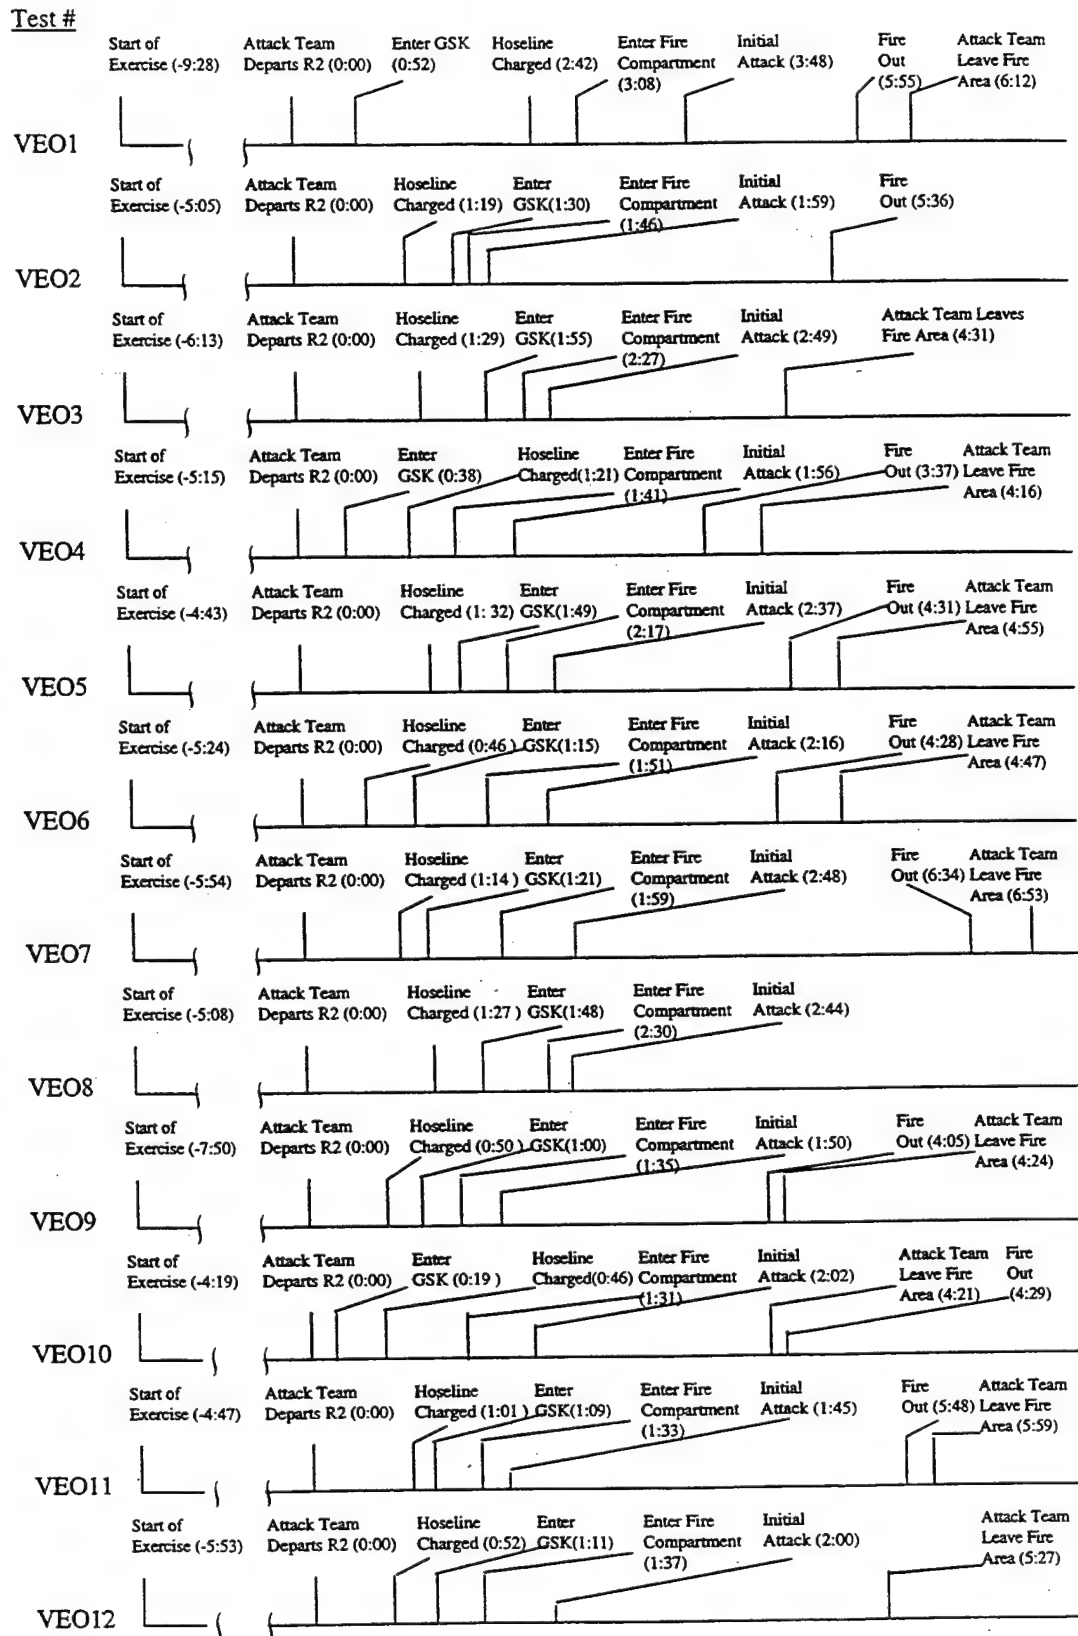
Fig. 13 — Event timelines for tests VEO1-VEO12

Items (a) through (f) allow a comparison of the traditional vs VE training methods because completion of these tasks is a function of familiarity with the space. Items (g) and (h) are dependent more on knowledge of firefighting tactics and procedures and, therefore, are not expected to be good indicators of the type of training received. As with the graphs, time zero for this evaluation began when the attack team departed from Repair 2. A graphical representation of these data is provided in Fig. 13.

Firefighter-response-time data presented in Fig. 13 indicate how well the attack team, under the direction of the test participant (team leader) was able to navigate the test space under realistic fire conditions. Selecting meaningful timing measures was difficult because different attack teams performed the required tasks in different sequences. For example, some teams charged the hose line in the starboard passageway rather than the GSK. In this case, it is not practical to evaluate the elapsed time required to man the hose line and enter GSK. In addition, data on times for the fire to be declared out and the attack team departed the fire compartment were not recorded for all tests and could not be evaluated.

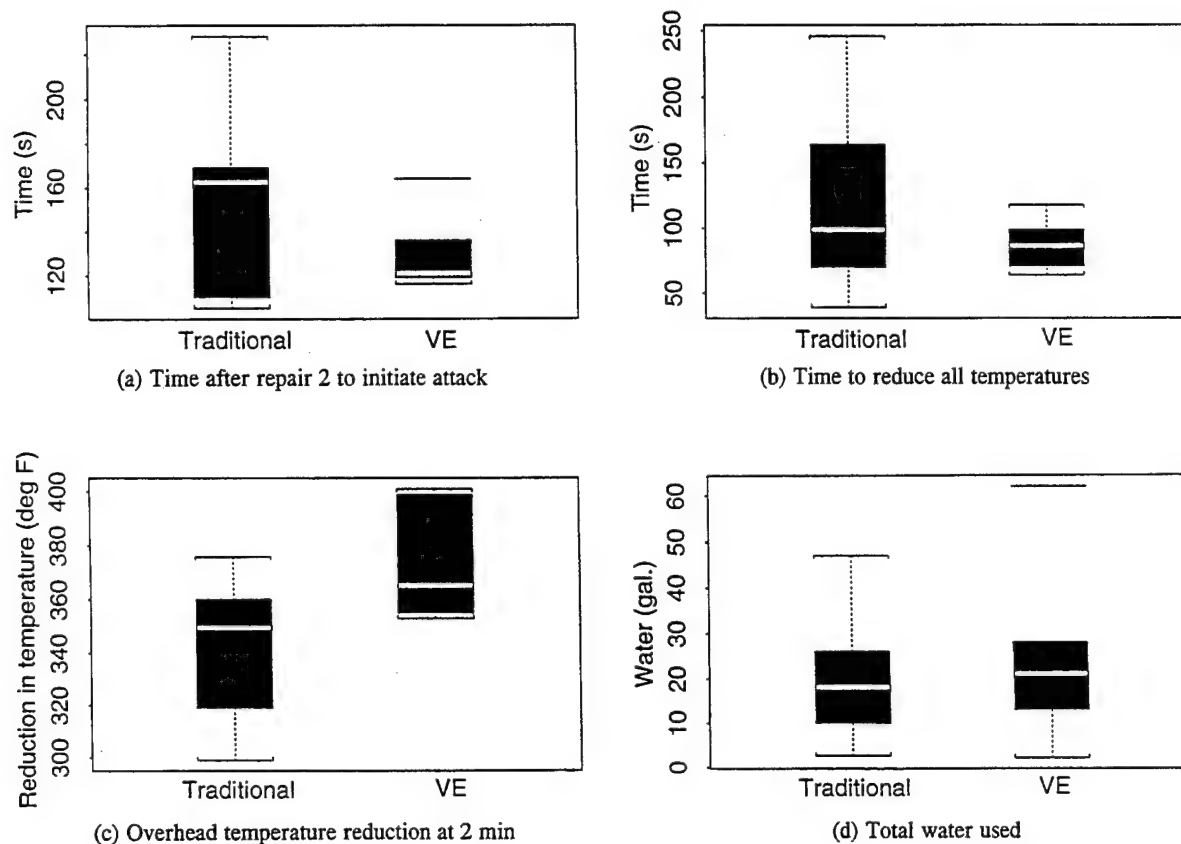
Fig. 14 — Box plots of key measures

Figure 14 shows a pair of box plots, one for each group, for each of the four key measures in Table 3. We have presented box plots (also called a box and whisker plots) because a box plot gives a picture of the variance (or spread) of the distribution for the data. The horizontal line in the interior of the box is located at the median of the data. The height of the box is equal to the interquartile distance (IQD), which is the difference between the third quartile of the data and the first quartile. The height of the box shows the variance if there are no outliers; two boxes of the same height indicate equal variance. If there are outliers, the size of the box is still a reasonable approximation of the variance. The whiskers (the dotted lines extending from the top and bottom of the box) extend to the extreme values of the data. Unusually deviant data (defined as data that are 1.5 times the IQD) are shown as lines above or below. The variances are markedly different for the top two data sets and similar for the bottom two in Fig. 14.

For the data for elapse time from departing Repair 2 to beginning the initial attack (Fig. 14(a)), the variance for the traditional group is more than six times greater than the VE group's. This difference suggests that the VE training group was more consistent in their approach during this phase. A formal test of the difference of variances is significant at $p < 0.06$, which is suggestive given the outlier in the VE group data. The VE group averages 26.7 s faster performance. More striking is the difference in performance between groups in the time to achieve extinguishment of the wood crib (i.e., the time required to reduce all wood crib temperatures below 150° C (302° F) (Fig. 14(b)). The variance is 16 times greater for the traditional group than the VE group. A formal hypothesis test of the difference of variances is highly significant at $p < 0.009$. (Note that the time for traditional group subject VE03 was thrown out because the fire was allowed to reflash to evaluate a thermal imager.) The traditional group is, on average, 36.1 s lower. The data suggest that rehearsing in VE helped the group perform the firefighting task in a more focused and consistent way.

The performance of both groups is similar for the bottom two measures in Fig. 14, which rely more on firefighter training. VE did help slightly to produce more consistent behavior, which can be seen in a variance that is somewhat less for the VE group in both cases. The variance for the traditional group for total reduction in average overhead temperature at 2 min after the initial attack is less than twice that of the VE group's (Fig. 14(c)). The VE group averages 26.2 s slower. These data are fairly reliable even with the reflashes. (Again, data for subject VE03 of the tradition training group were thrown out.) The graphical data for average overhead temperature show that the reflashes that did occur (as indicated by the wood crib temperature data) were not large enough to be measured at the overhead and did not pose a serious thermal threat. A formal test of difference in variances is not significant. The cumulative total water flow data are also similar (Fig. 14(d)). The difference in variance is only 124.7 (with the traditional group's larger) and is not significant. The average difference in amount is only 3.79 gal more for the VE group.

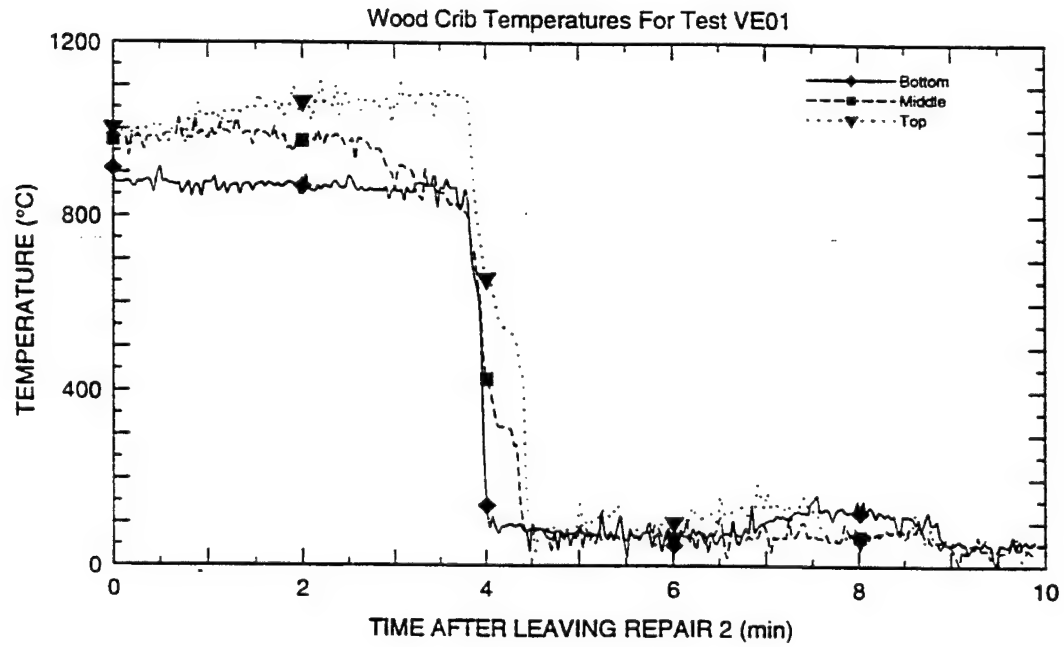
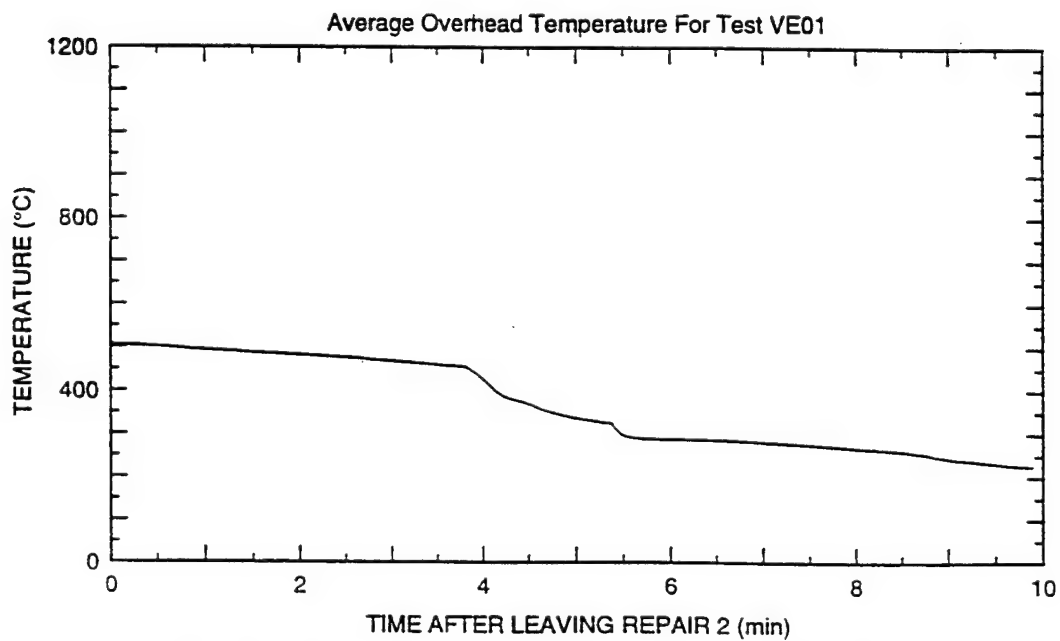
Fig. A1 — Wood crib and average overhead temperatures for test VE01

Graphical presentation of this data is provided in the Appendix. These graphs are based on time zero being when the attack team departed from Repair 2 and passed through QAWTD 2-15-1. Up to that point in time, the test participants were unaffected by the fire conditions. Once the attack team entered into the starboard passageway, they were exposed to the smoke and heat being generated by the fire. In reviewing these graphs, note that the cumulative total water flow data include the flow necessary to charge the handline. This volume accounts for 35 L (9.2 gal) of the total flow.

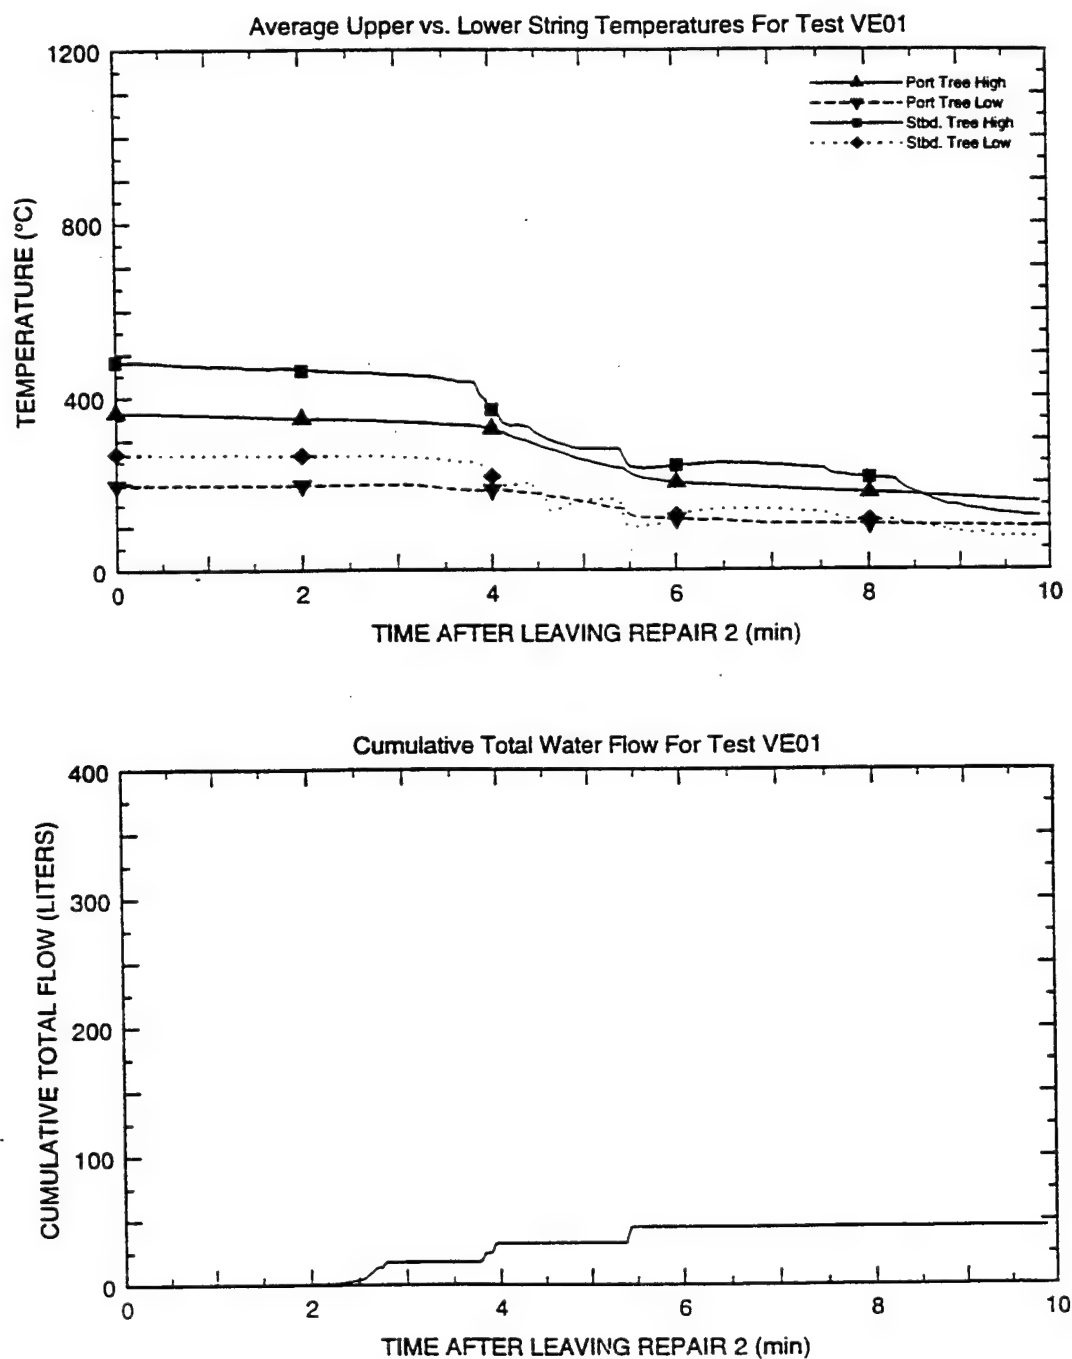
Fig. A2 —Average string temperatures and cumulative total water flow for test VE01

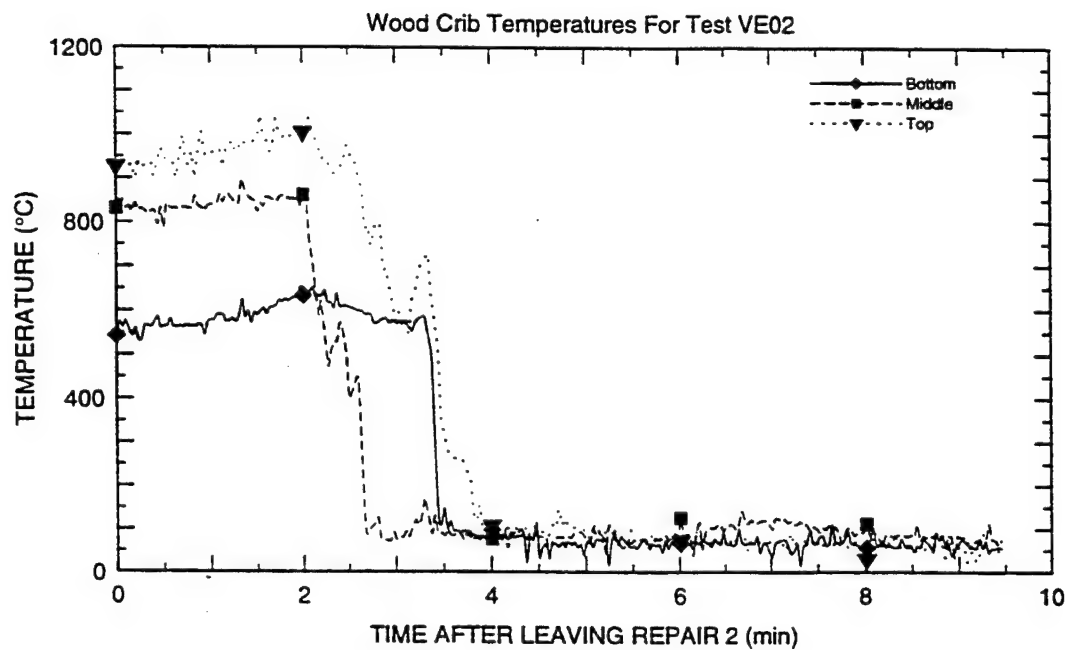
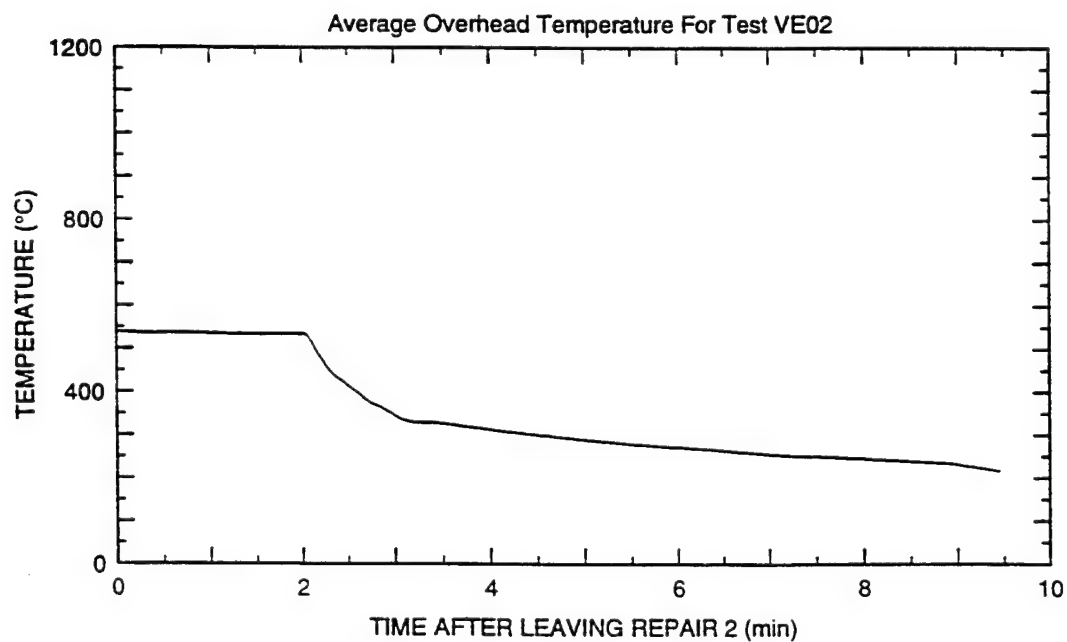
Fig. A3 — Wood crib and average overhead temperatures for test VE02

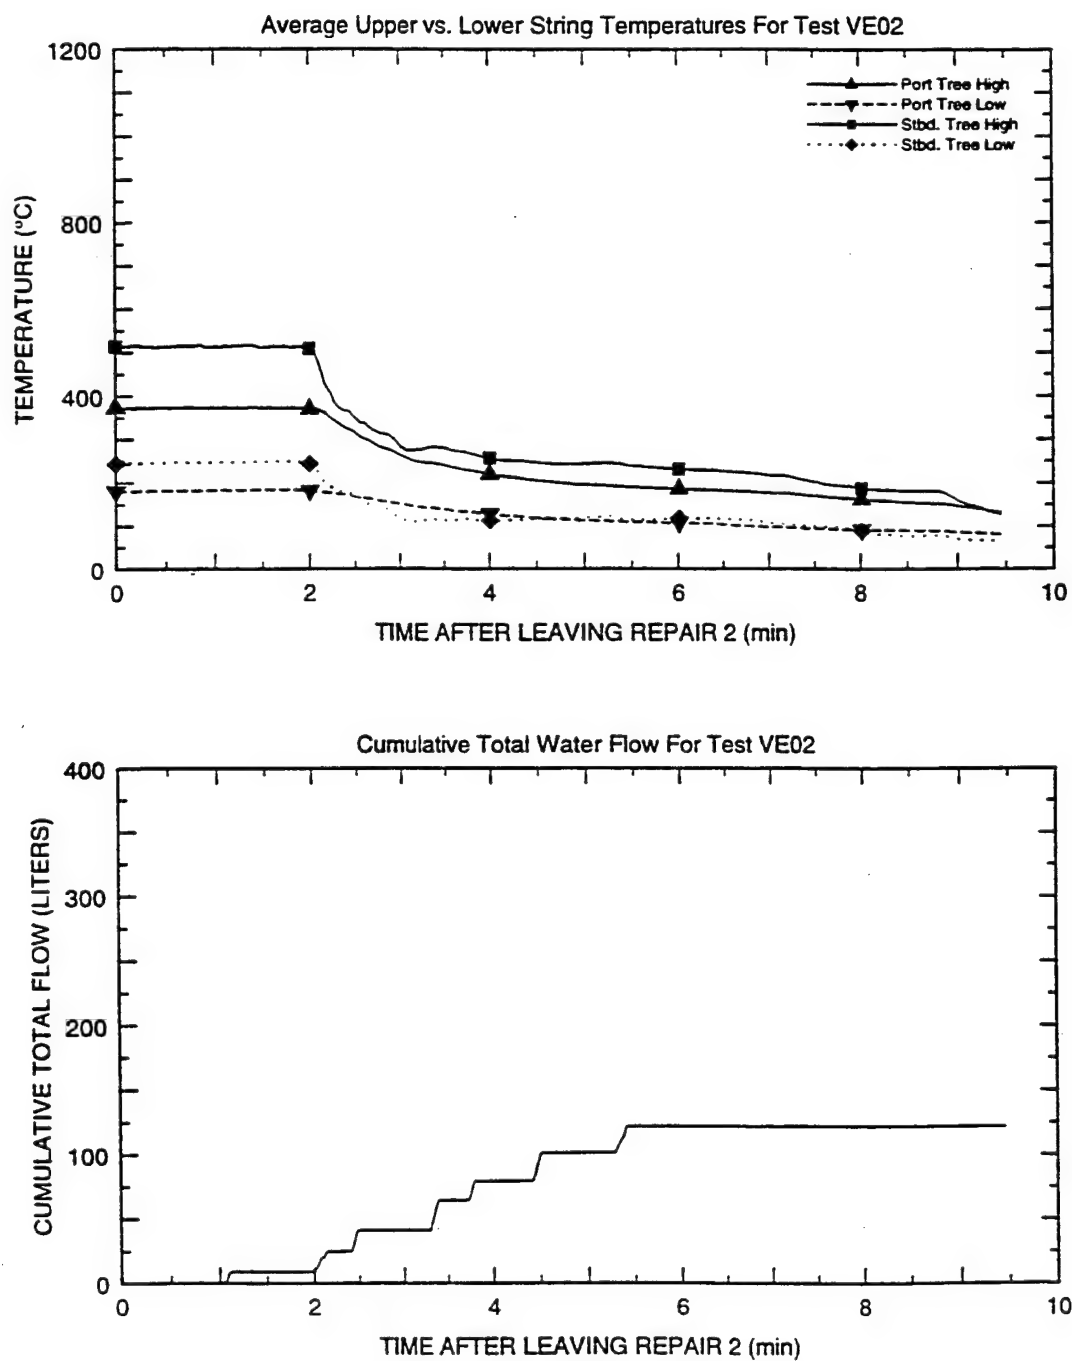
Fig. A4 — Average string temperatures and cumulative total water flow for test VE02

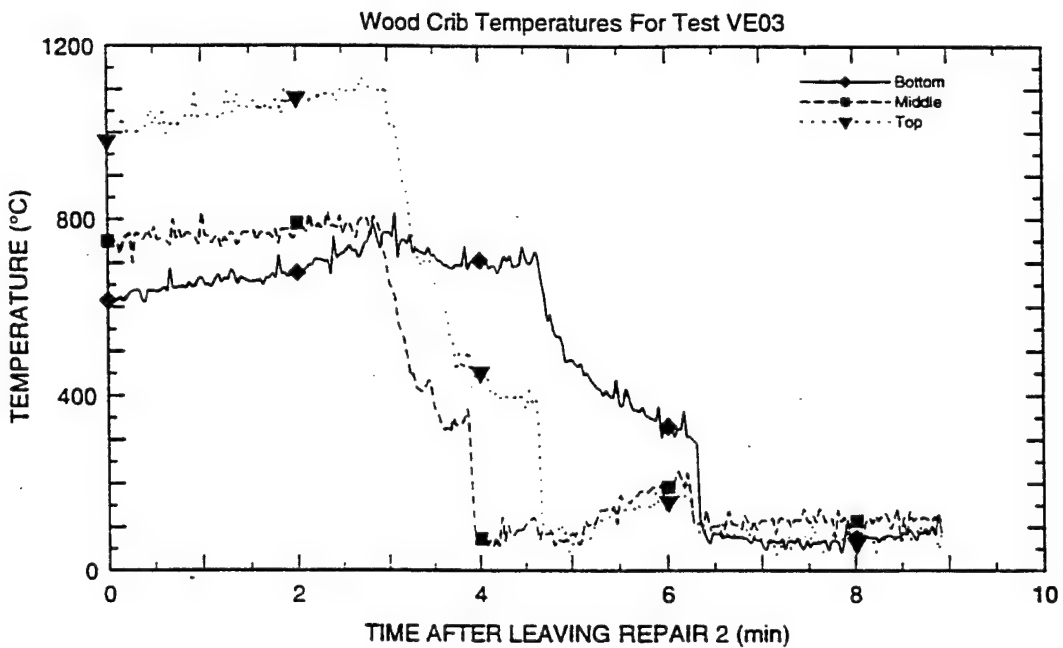
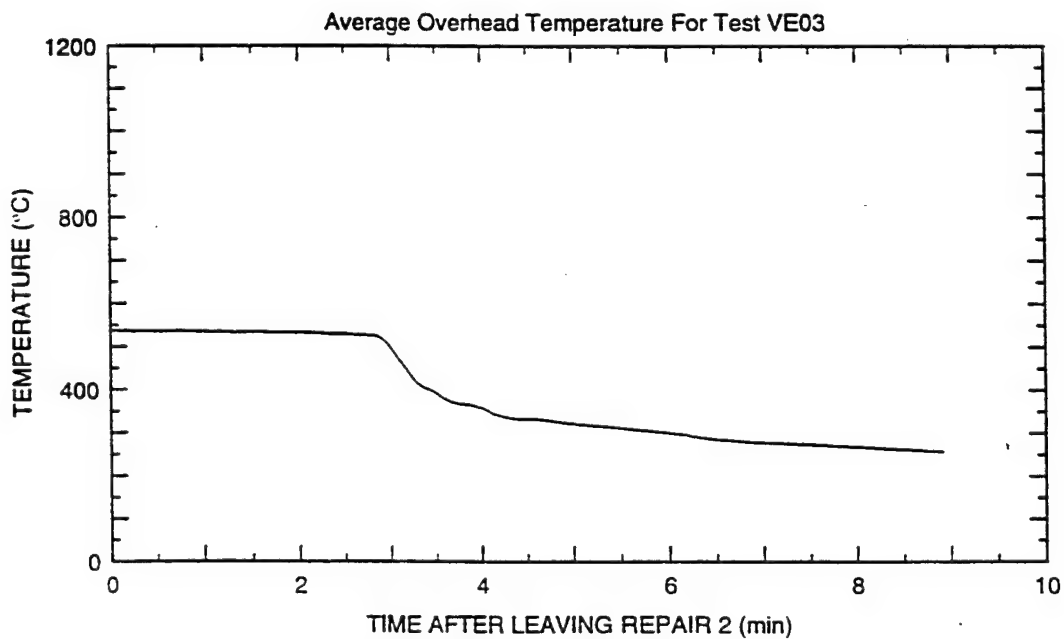
Fig. A5 — Wood crib and average overhead temperatures for test VE03

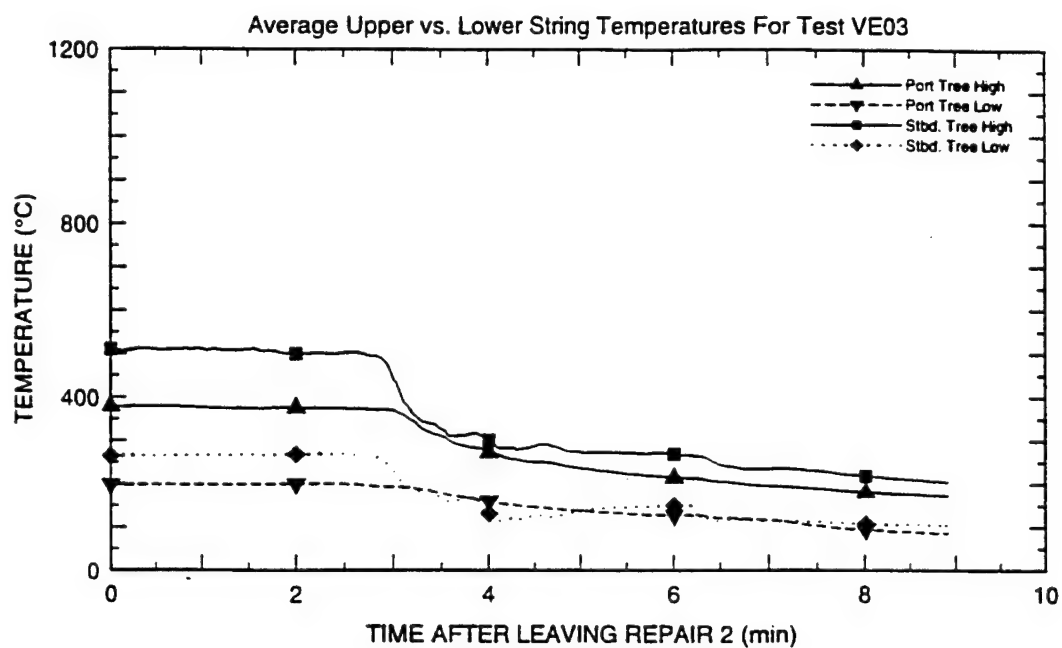
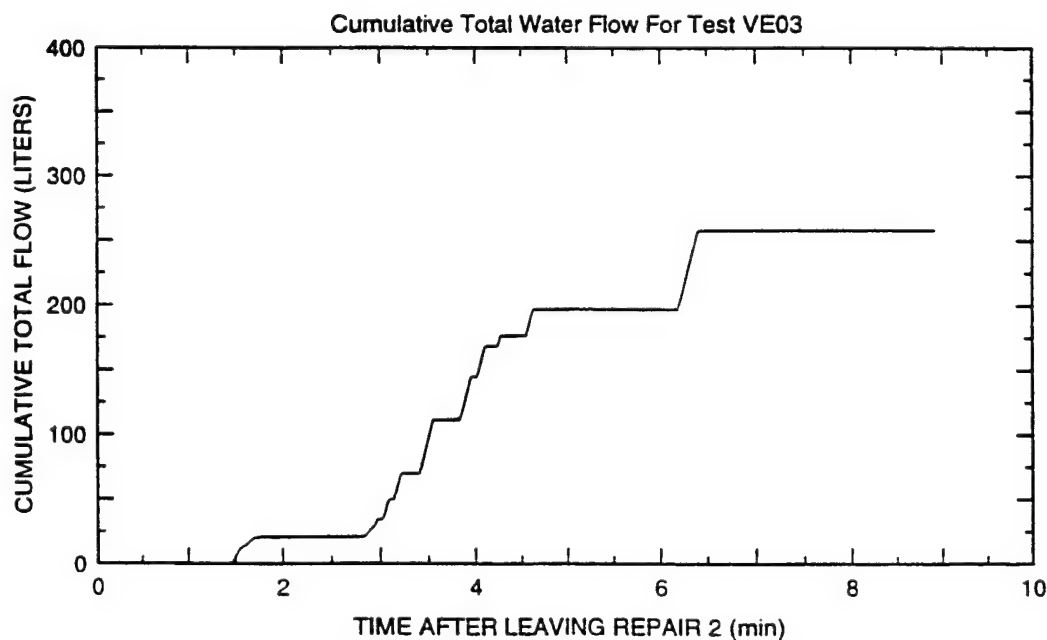
Fig. A6 —Average string temperatures and cumulative total water flow for test VE03

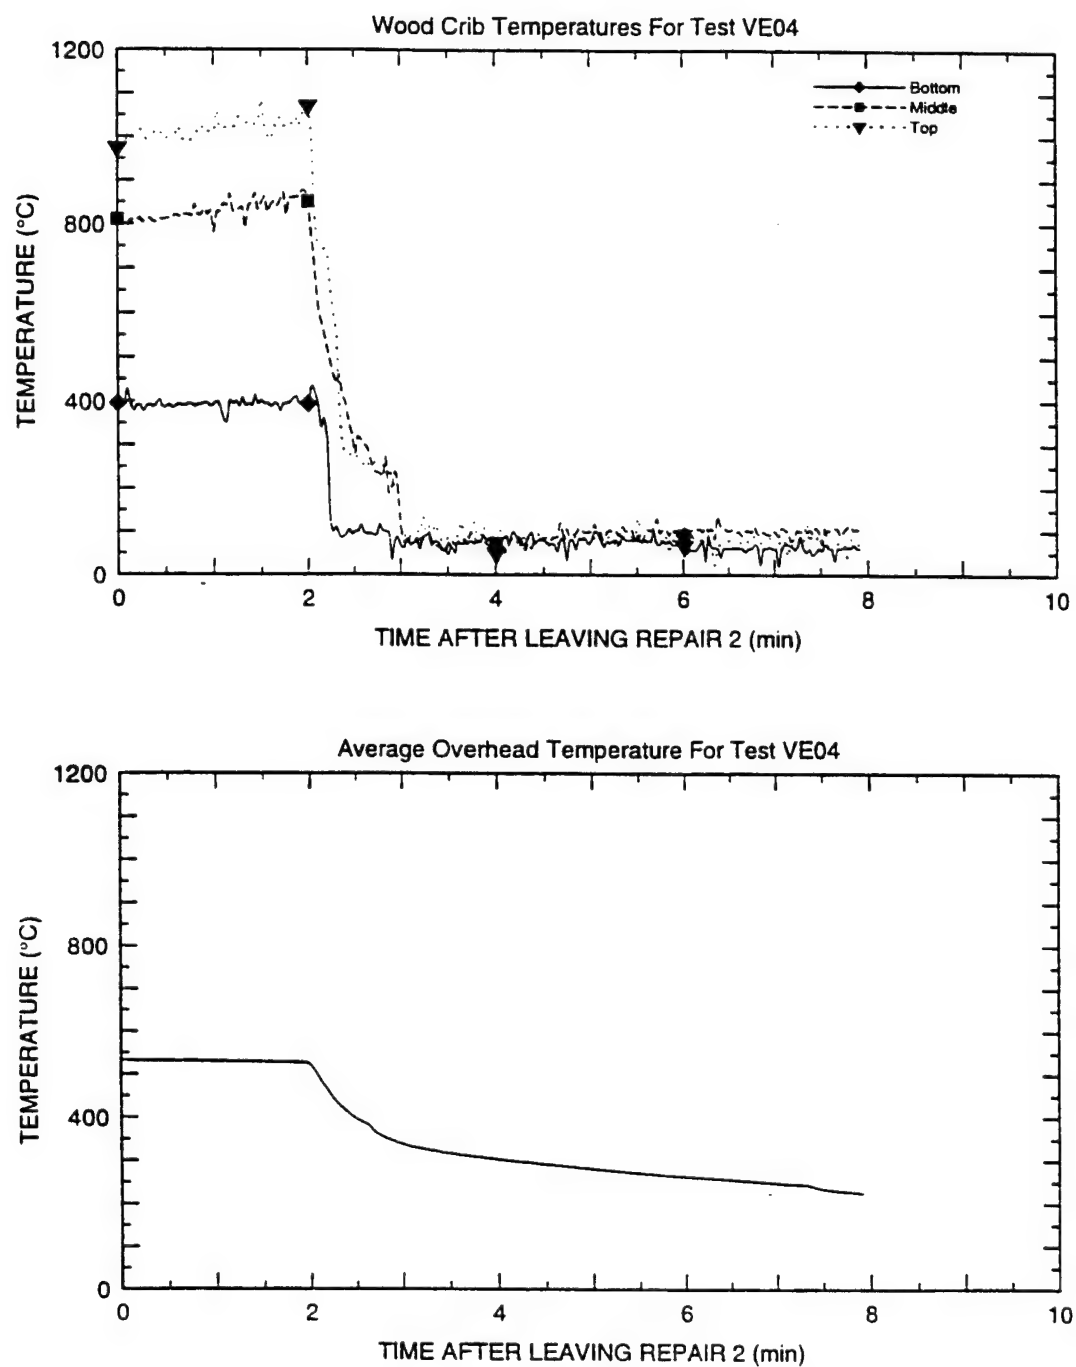
Fig. A7 — Wood crib and average overhead temperatures for test VE04
